SPEED TESTS CONDUCTED IN CANADA  
DURING MUSKEG TRAFFICABILITY  
TEST PROGRAM, AUGUST 1962

MISCELLANEOUS PAPER NO. 4-621

July 1963

U. S. Army Engineer Waterways Experiment Station  
CORPS OF ENGINEERS  
Vicksburg, Mississippi

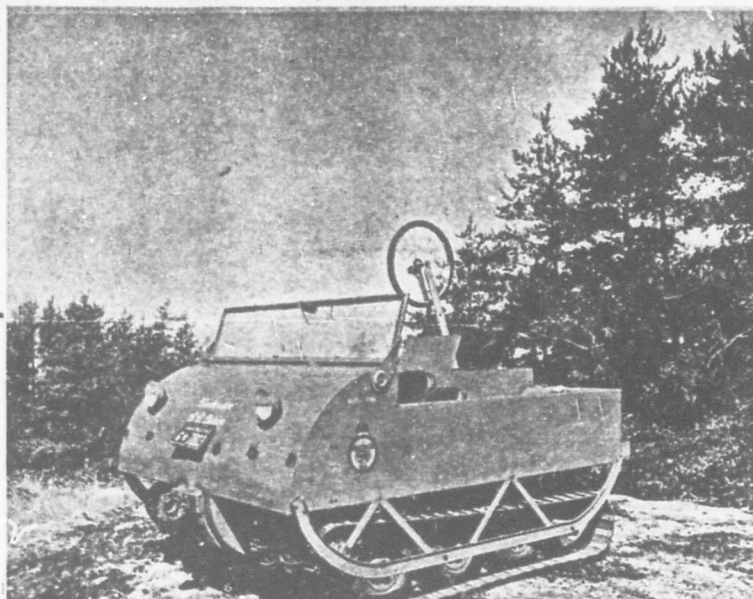
10. The Bombardier completed the test run faster than the other vehicles in both tests 1 and 2. The bombardier was able to maneuver and turn faster than the other vehicles; however, it was the roughest riding vehicle in both tests. The vehicle was apparently not damaged in either test although it later developed motor steering clutch trouble.

d. The Bombardier completed the test course in the least time in both tests; however, it was the roughest riding vehicle tested. It also had the best maneuverability. The Dinah and the Buffalo proved to have the best riding qualities.

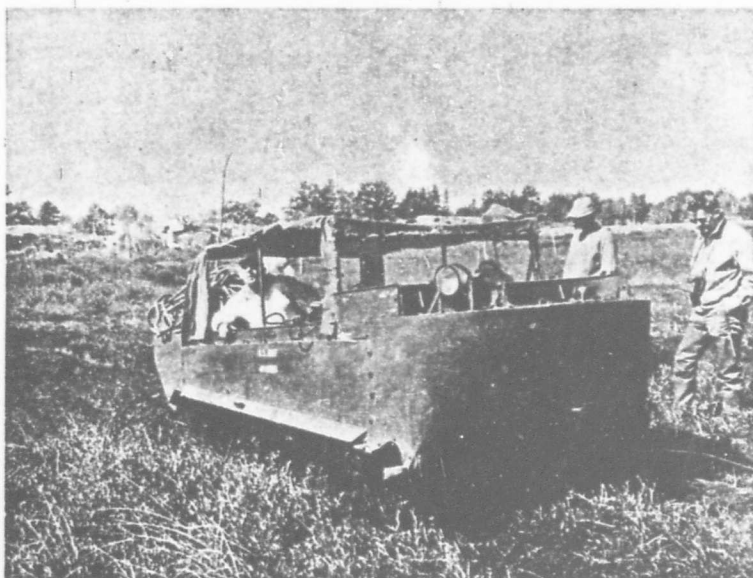
11. The M29C weasel with 12-in. tracks was the second fastest vehicle in test 1 and the third in test 2. It rode somewhat better than the Bombardier in both tests, but its maneuverability was not quite as good. The vehicle suffered a bent front idler, and its front pontoon was damaged in test 1; there was no damage in test 2.

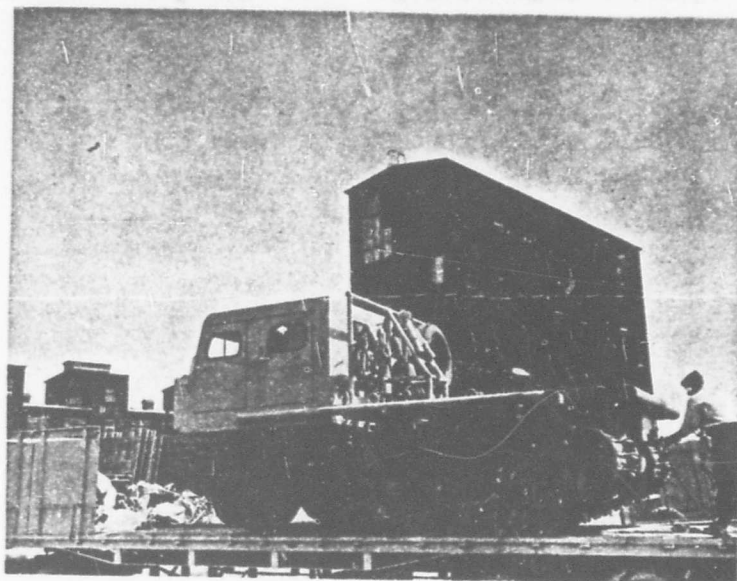
Nodwell RN110

12. The Nodwell RNL10 finished third in test 1 and fifth in test 2. Its ride was smoother than the Bombardier's in these tests. Its maneuverability was poorer than that of the Bombardier, the two weasels, and the Dinah. Several bolts in the frame of the RNL10 were shaken loose in test 1; there was no damage to the vehicle in test 2.

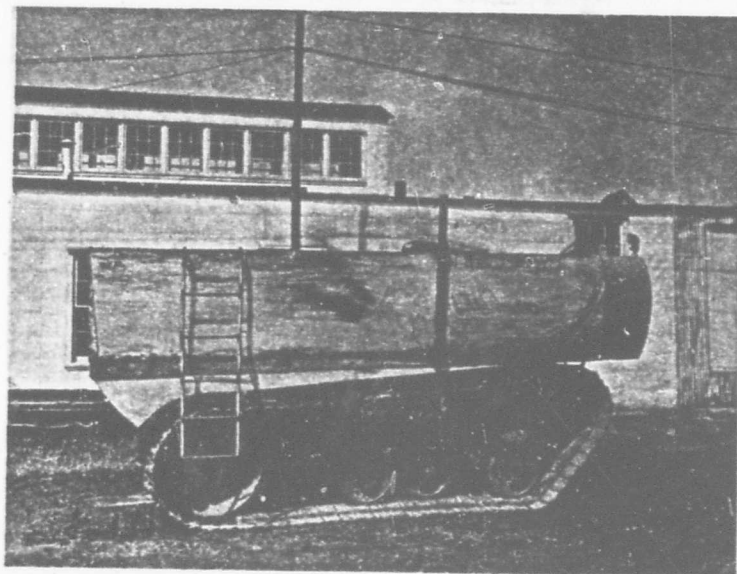
13. The Buffalo, slowest vehicle in both tests, traversed most of the test course in test 1 at its maximum available speed. Thus its speed was controlled by the low gear ratio of its transmission rather than by the microrelief of the test course. This vehicle's riding quality was about the same as that of the RNL10, although its ride would probably have been rougher had the vehicle approached the speed of the other vehicles. It could not be maneuvered as fast as the Bombardier, the two weasels, or the Dinah. The Buffalo was not damaged in test 1 except that the spare battery turned over; the vehicle was not damaged in test 2.

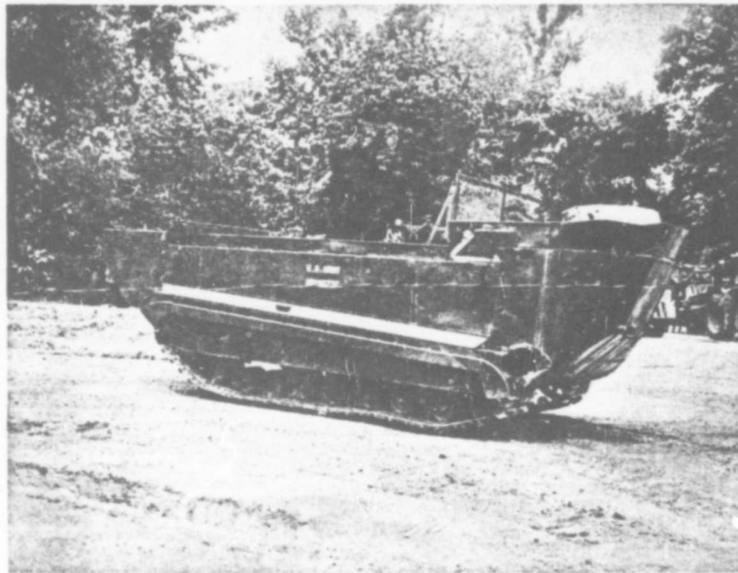
14. The M29C weasel with 20-in. tracks was not tested in test 1. In test 2, this weasel finished fourth. The riding quality was about the same as that of the weasel with 12-in. tracks, but the weasel with 20-in. tracks had more trouble turning because of a worn steering clutch. The vehicle was not damaged in this test.

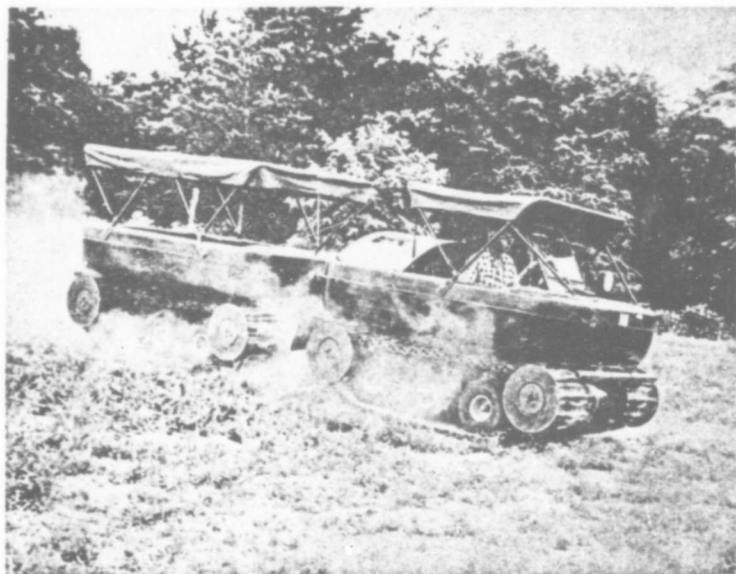
15. The Dinah, an articulated vehicle, was not tested in test 1; however, it finished second in test 2. This vehicle's maneuverability was probably about the same as that of the weasel with 12-in. tracks. Its riding quality was the best of the vehicles tested. The Dinah did not suffer damage in this test; however, the front track guides were damaged on similar terrain when the Dinah was climbing sharp slopes.

c. The articulated system of the Dinah, no doubt, is an asset to the vehicle's good riding qualities and maneuverability.

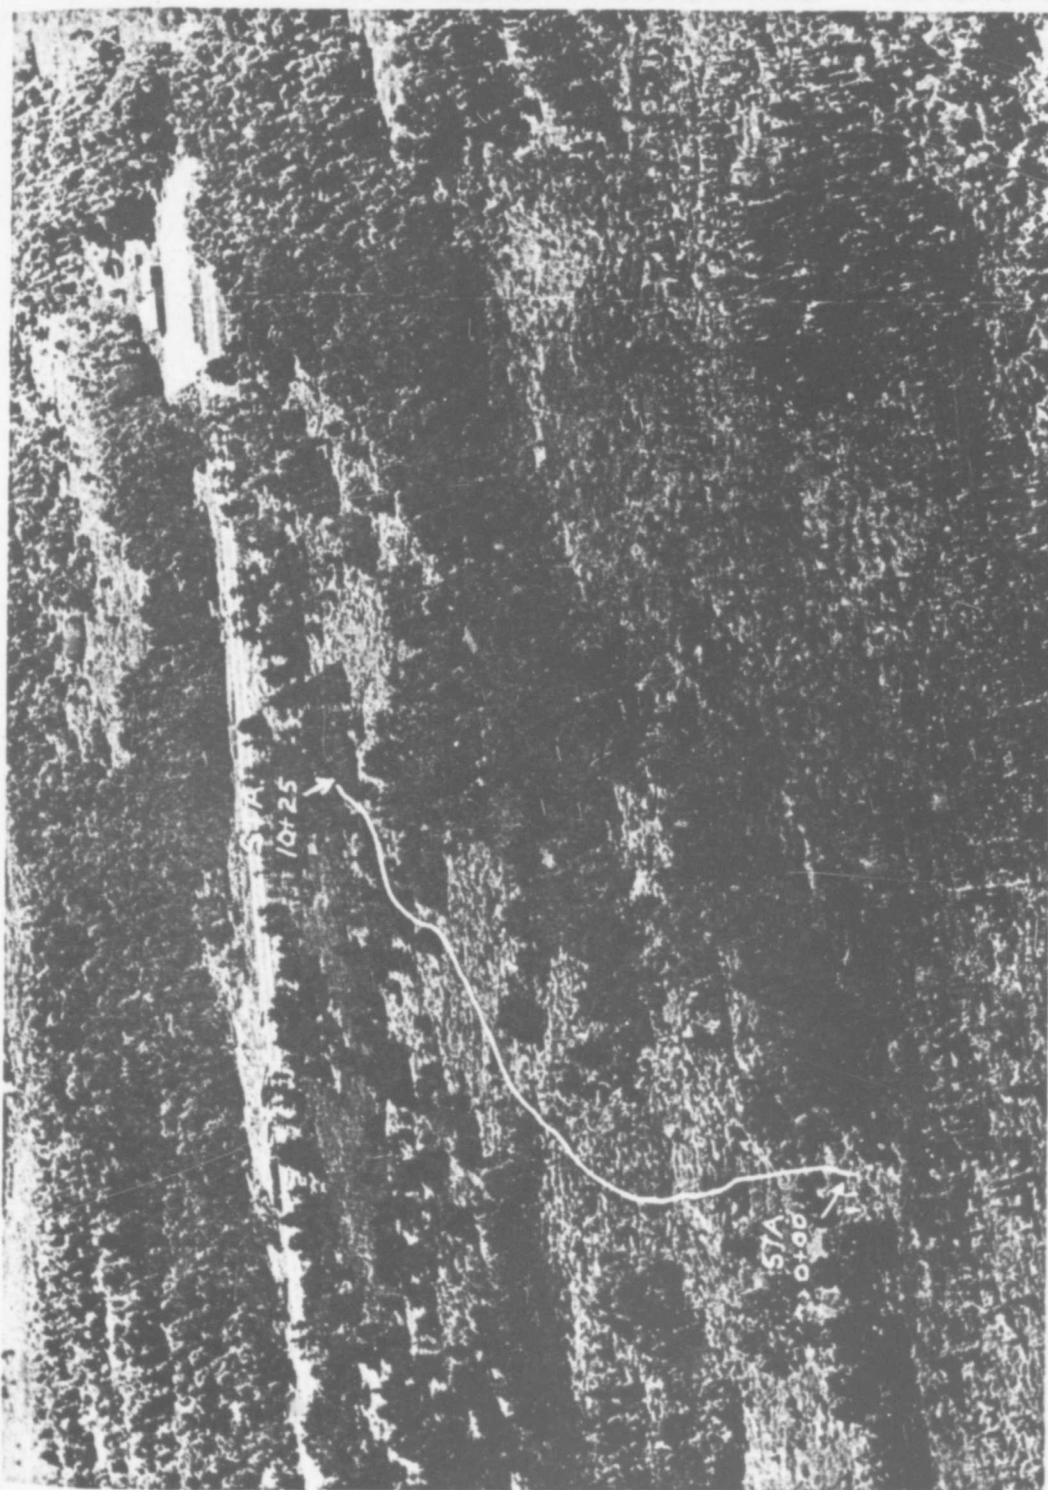
4. The test course, 1025 ft long and 40 ft wide, was laid out with a pocket transit and a Wye level about 15 miles north of Parry Sound and 75 yd west of Highway 69. An aerial view of the course is presented in inclosure 3. Representative photographs of the course are shown in inclosure 4, beginning at station 0+00 and continuing along the course to the end. Vegetation data are presented in inclosure 5.

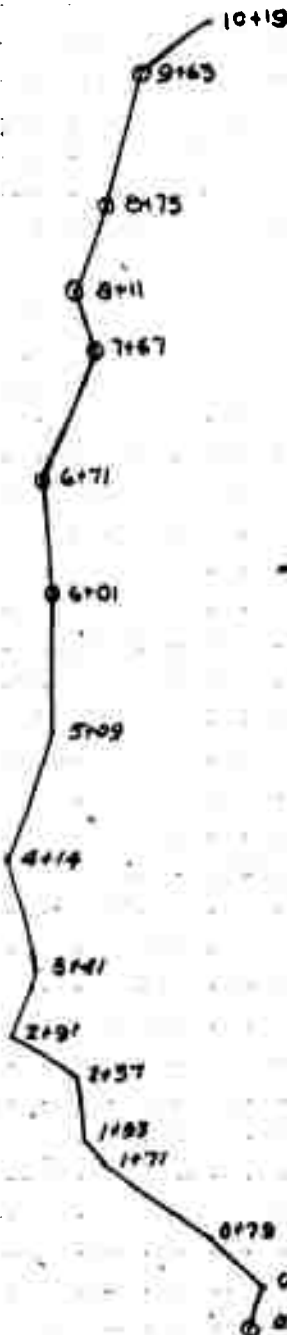
## TRAVERSE

6. Traverse and profile data of the course are presented in inclosures 6 and 7, respectively. Microgeometry data were obtained at stations 2+50 and 5+01 on the test traverse. These two microgeometry sample cells characterize the surface roughness of the area. The top views of the sample cells and the profiles along the radii of each cell are presented in inclosure 8.

<u>Traverse</u>			
<u>Station to</u>	<u>Station</u>	<u>Dist</u>	<u>Azimuth</u> <u>(North = 0)</u>
0+00	0+29	29	105°
0+29	0+79	50	40°
0+79	1+71	92	35°
1+71	1+93	22	46°
1+93	2+37	44	82°
2+37	2+91	54	52°
2+91	3+41	50	110°
3+41	4+14	73	74°
4+14	5+09	95	111°
5+09	6+01	92	90°
6+01	6+71	70	84°
6+71	7+67	96	114°
7+67	8+11	44	65°
8+11	8+73	62	112°
8+73	9+63	90	105°
9+63	10+19	56	144°

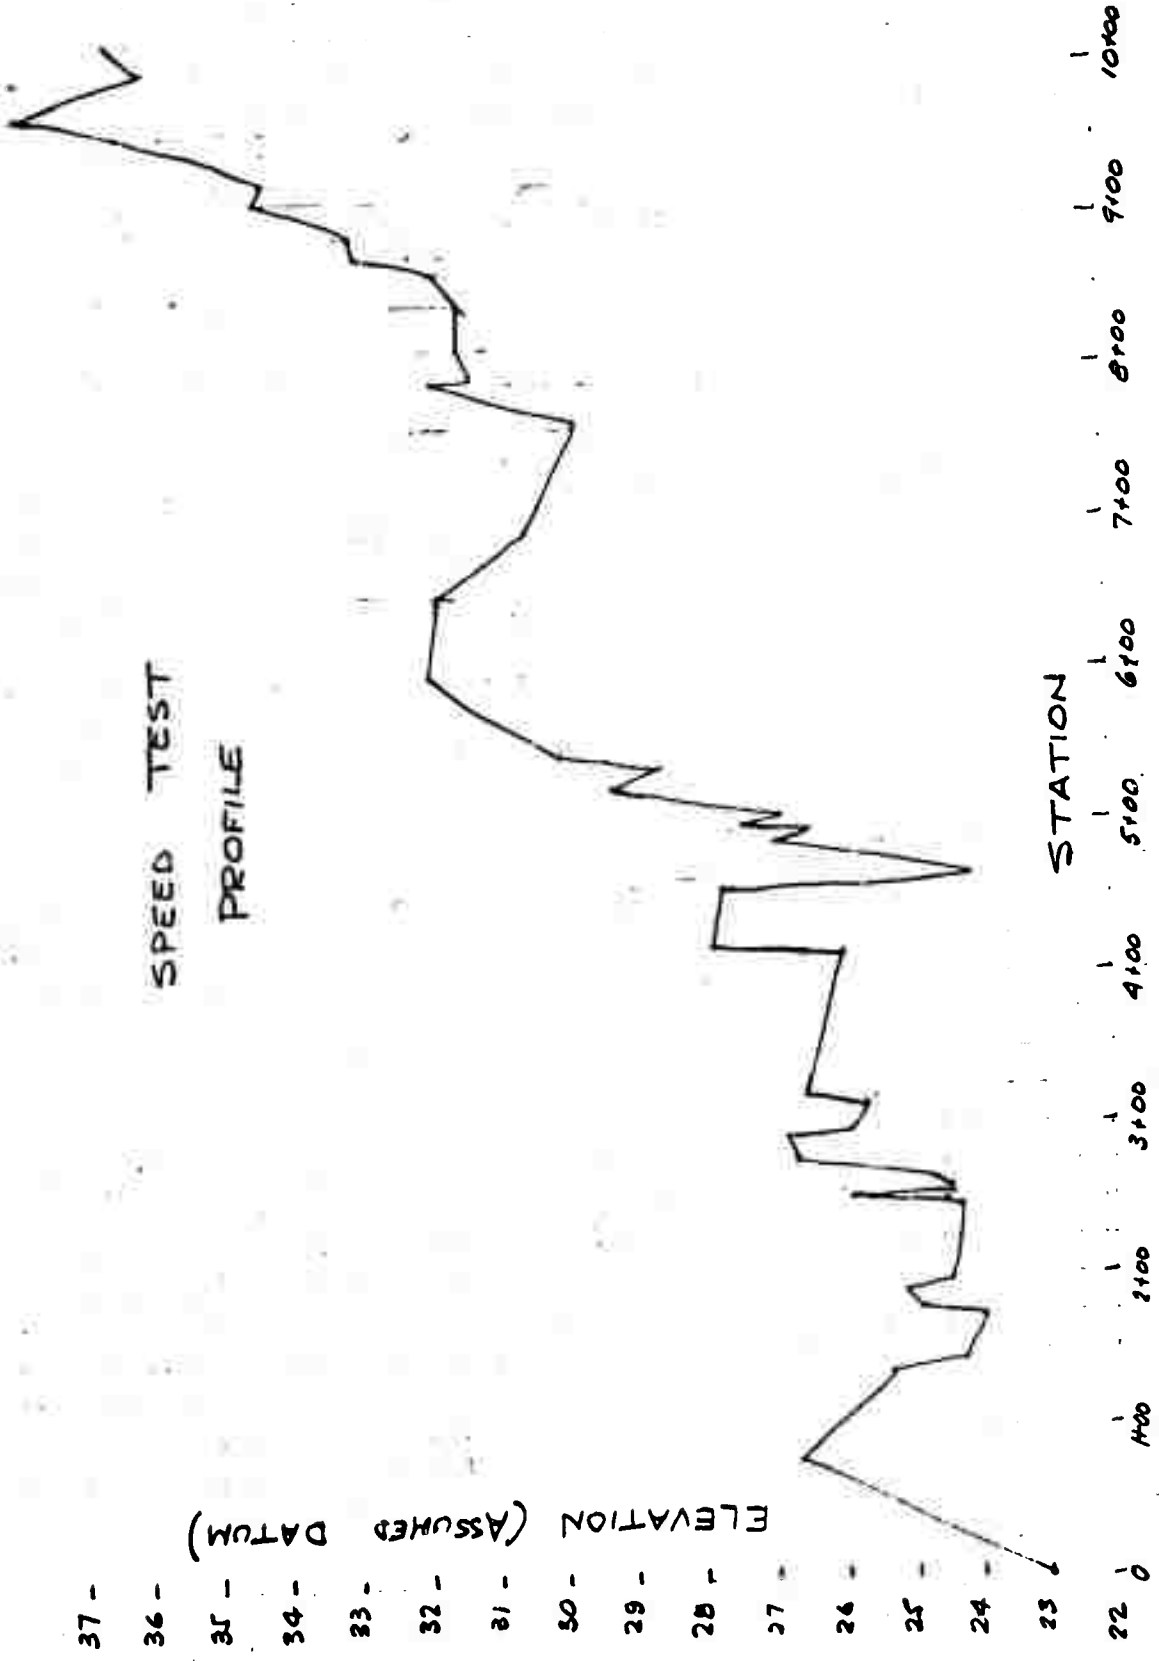
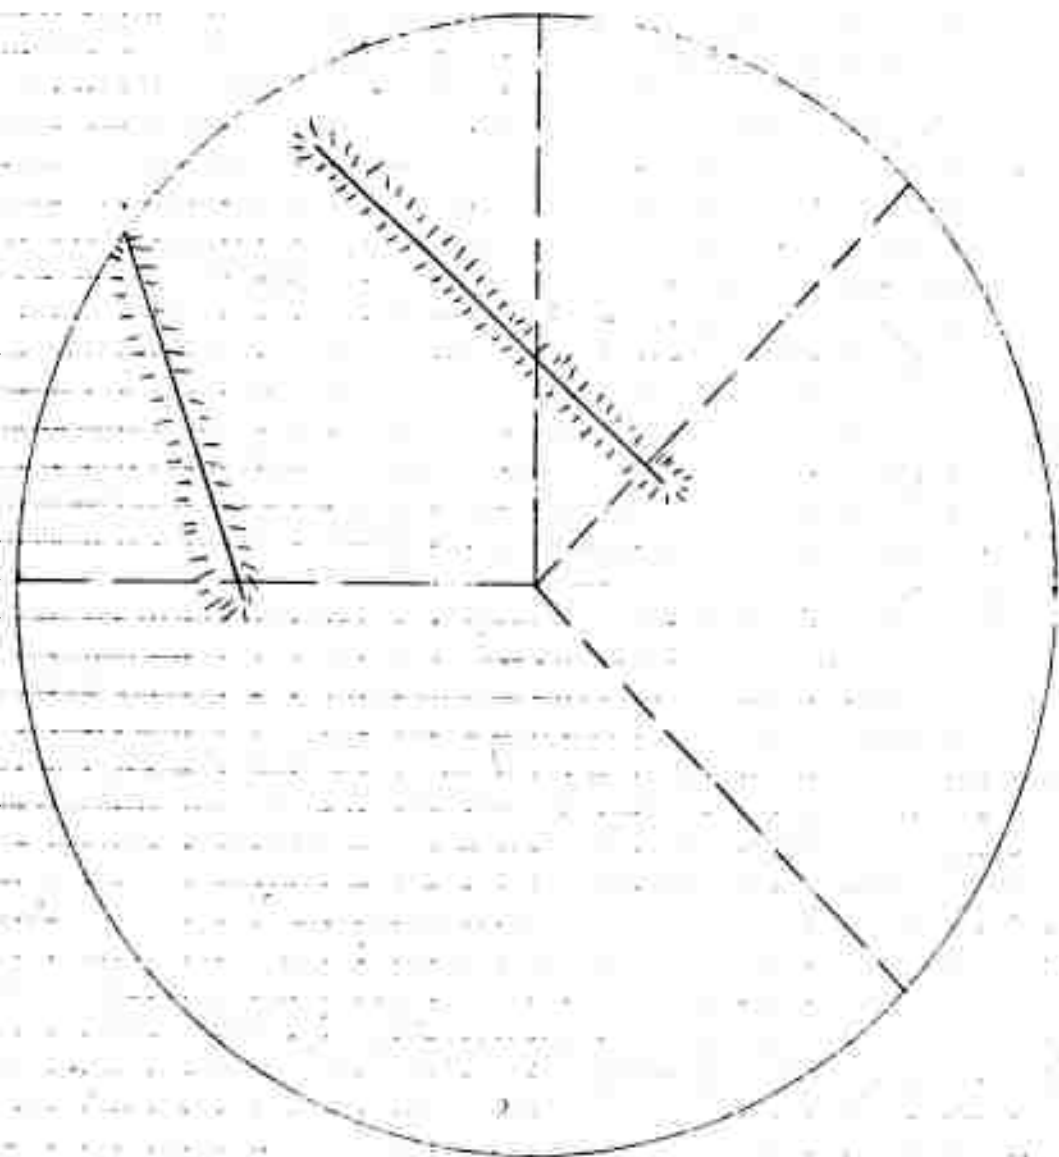
Microgeology

Time tests 1 and 2, sta 2+50  
11 A, 1962

Scale: 1 in. = 10 ft

17. Microgeometry. Examination of the top views of the microgeometry sample cells and their profile plots (inclosure 8) reveals elongated features in the area that generally lie in a north-south direction, which is approximately at right angles to the direction of the test course. One such feature, crossed by the 0° radius line in the microgeometry sample cell at station 2+50 had a 13-in. vertical rise on one side and an 11-in. fall on the other side within a horizontal distance of 14 ft. The drivers decreased their vehicle speed when they crossed features such as this.

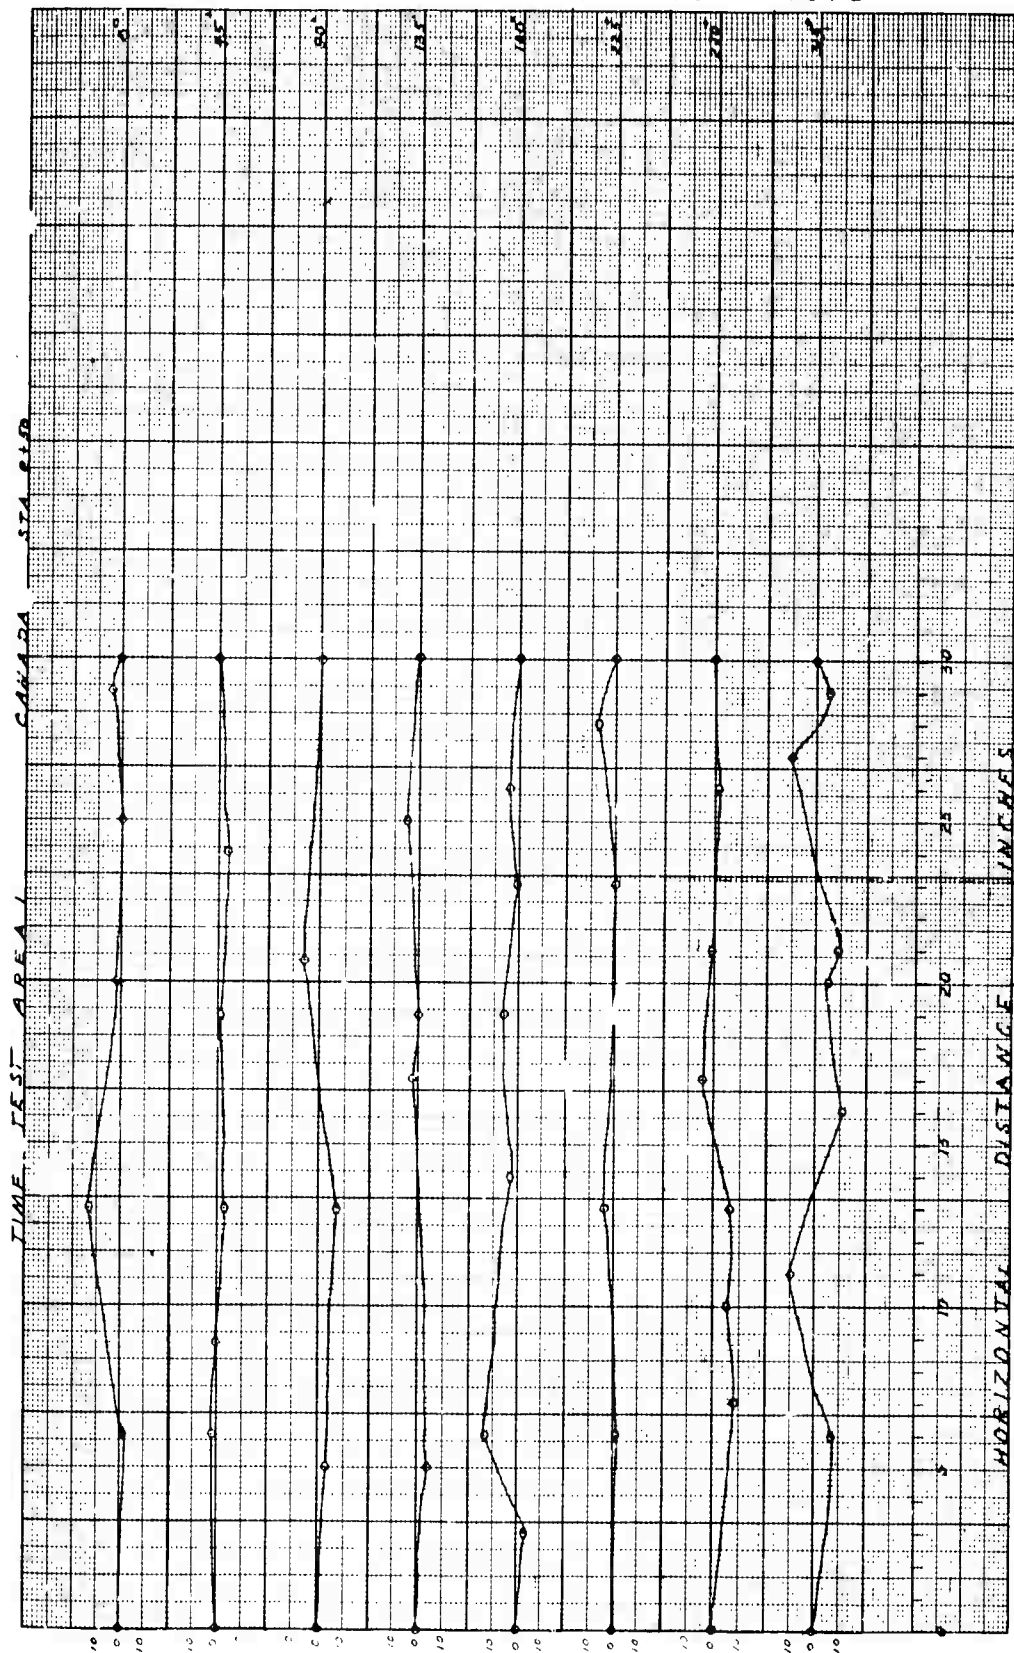
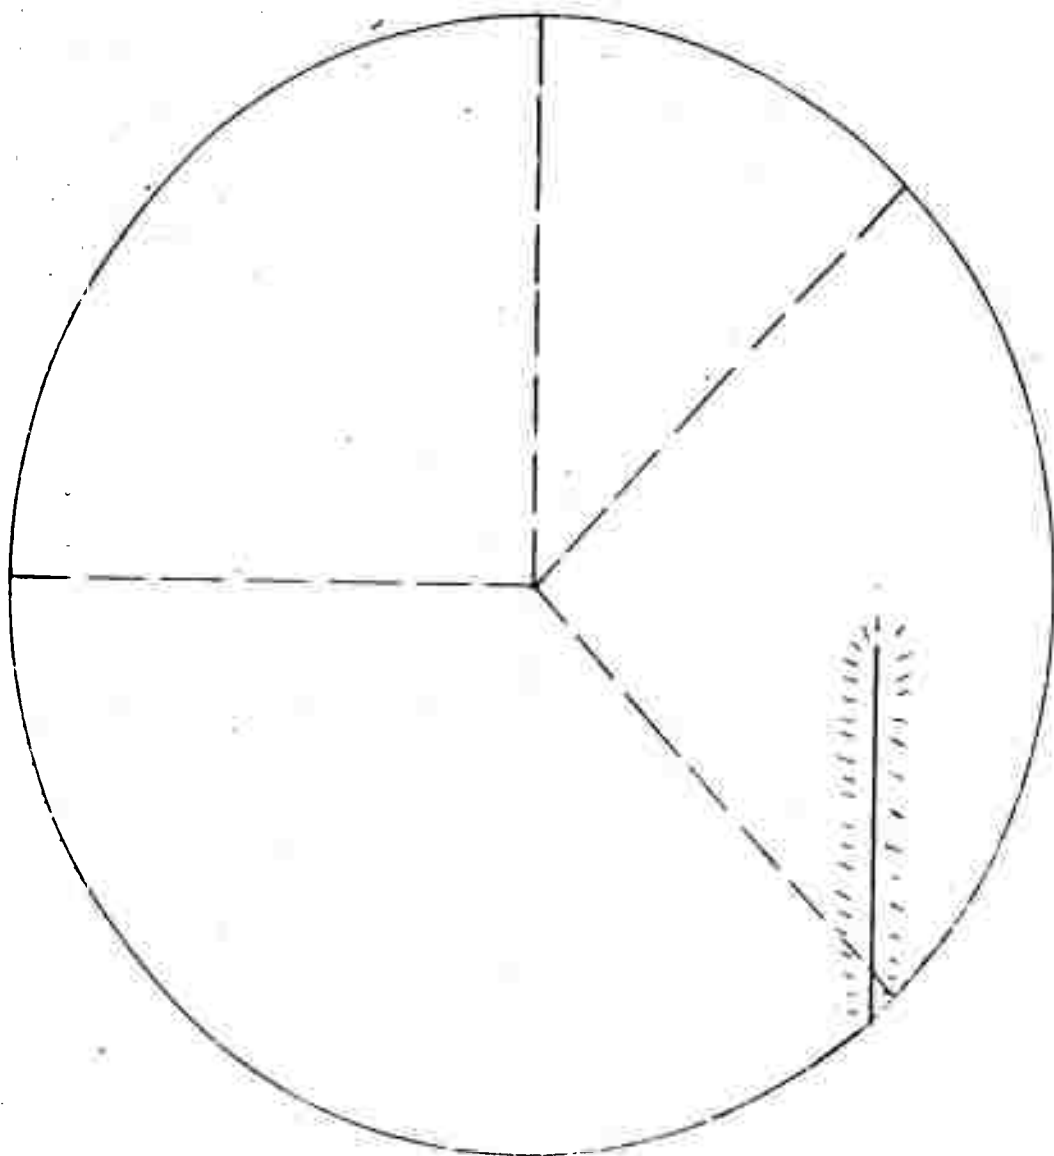
## Microgeometry

Time tests 1 and 2, sta 5+01

Scale: 1 in. = 10 ft

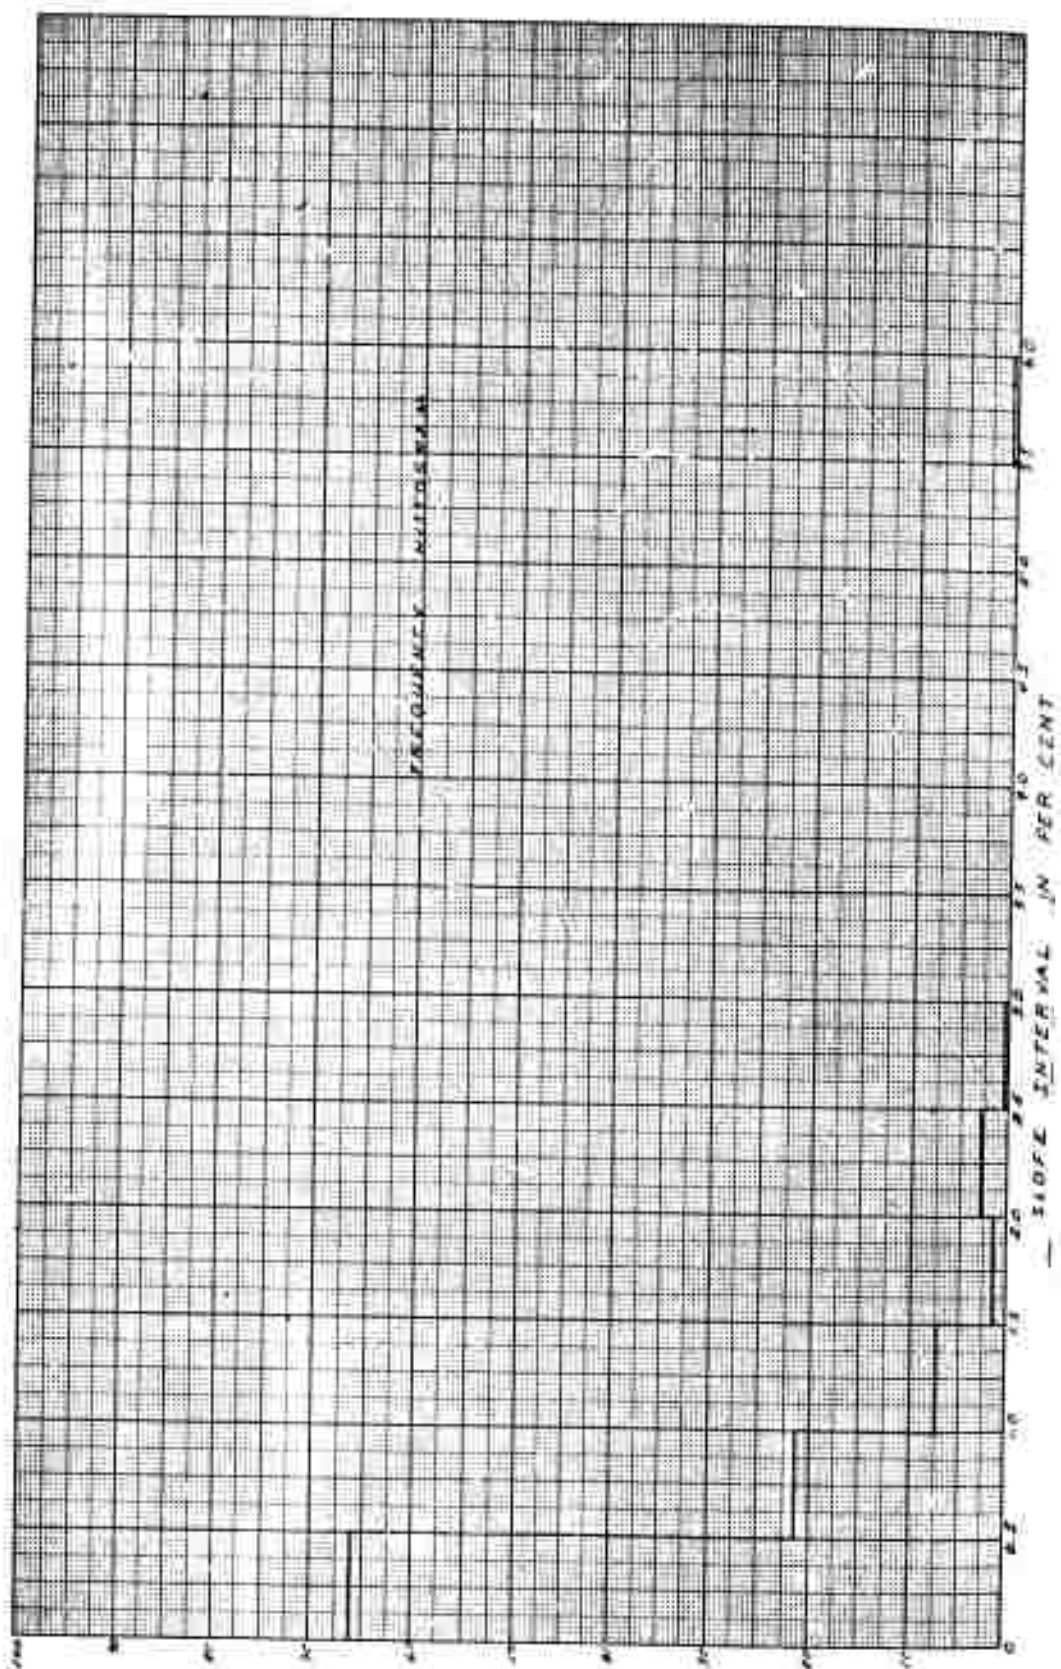
18. The frequency of occurrence of slopes along the length of the test course in percent is shown as a histogram in inclosure 9; the data for this plot are presented in inclosure 10. The histogram shows that the predominant slopes lie between 0 and 0.5 percent.

<u>Slope Interval in percent</u>	<u>Percent Coverage</u>	<u>Distance in ft</u>
0.0 - 0.5	66.14	678
0.5 - 1.0	21.40	219
1.0 - 1.5	7.40	76
1.5 - 2.0	1.36	14
2.0 - 2.5	2.74	28
2.5 - 3.0	0.48	5
3.0 - 3.5	0.00	0
3.5 - 4.0	0.00	0
4.0 - 4.5	0.00	0
4.5 - 5.0	0.00	0
5.0 - 5.5	0.00	0
5.5 - 6.0	0.48	5
